**An Investigation of the Water
Quality and Condition of Pipe in
Existing Automatic Sprinkler
Systems for the Analysis of
Design Options With Residential
Sprinkler Systems**

August 1982

J.E. Alleman, J.A. Milke
and H.E. Hickey

University of Maryland
Dept. Of Fire Protection Engineering
and Civil Engineering
College Park, MD

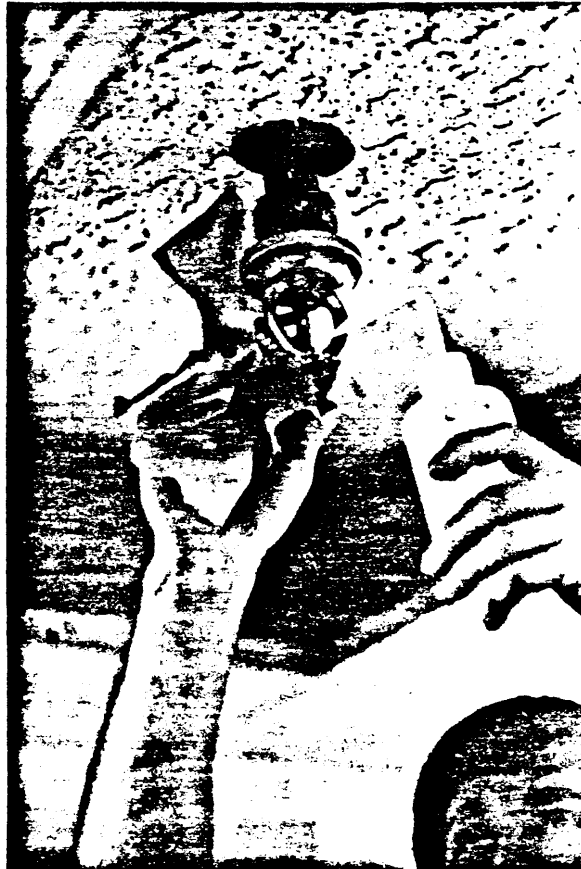
Figure 3. Sampling Site Cleansing/Sterilization with Ethanol

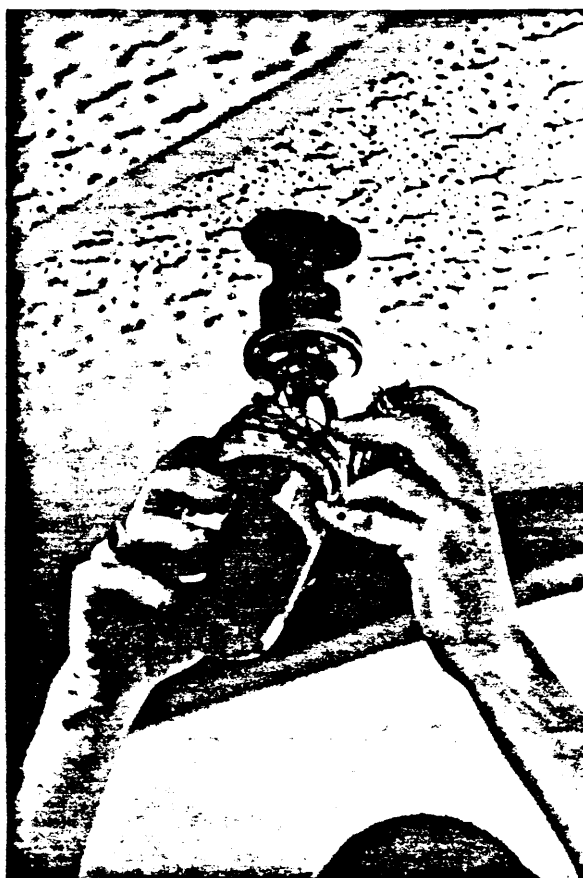
Figure 5. Collection of Initial Sample Aliquot in Sterile Glass Bottle

water sample was collected in a pre-sterilized glass bottle. During the collection of this sample, **as** depicted by Figure 5, every effort was made to minimize potential contamination. On occasion though, it was readily evident that the sprinkler line was not adequately pre-sterilized. As a case in point, an inspector's test site yielded a cockroach during this initial sampling. Such observations were fortunately uncommon.

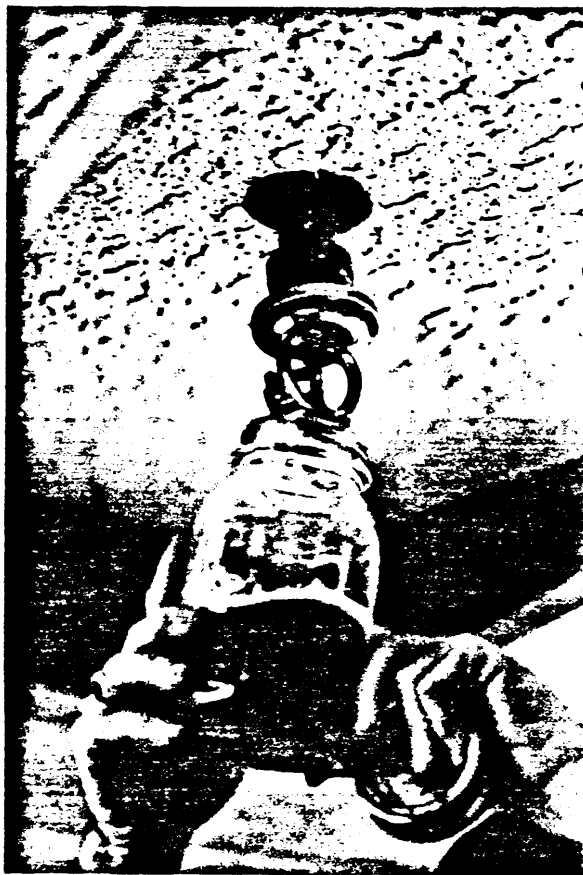
Figure 6. Collection of General 1500ml Sample Aliquot

Figure 6 depicts the subsequent collection of a general 1500 ml water specimen, also using a glass bottle. When possible, control samples were taken from the proximity of the test site. These controls were usually obtained from nearby bathroom water faucets. These latter samples provided a quality control check, particularly on the sterilization measures. The controls also established a baseline for comparison with the sprinkler data. **As** with the sprinkler lines, two control sample aliquots (**i.e.** 500 and 1500 ml) were collected for the general and biological analyses.
